**CONSENT ORDER
ISSUED UNDER THE
WATER POLLUTION CONTROL ACT
WEST VIRGINIA CODE, CHAPTER 22, ARTICLE 11**

TO: Mountain Valley Pipeline, LLC
Attn: Robert J. Cooper
Senior Vice President, Engineering and Construction
625 Liberty Ave, Ste 1700
Pittsburgh, PA 15222

DATE: April 19, 2019

ORDER NO.: 8951

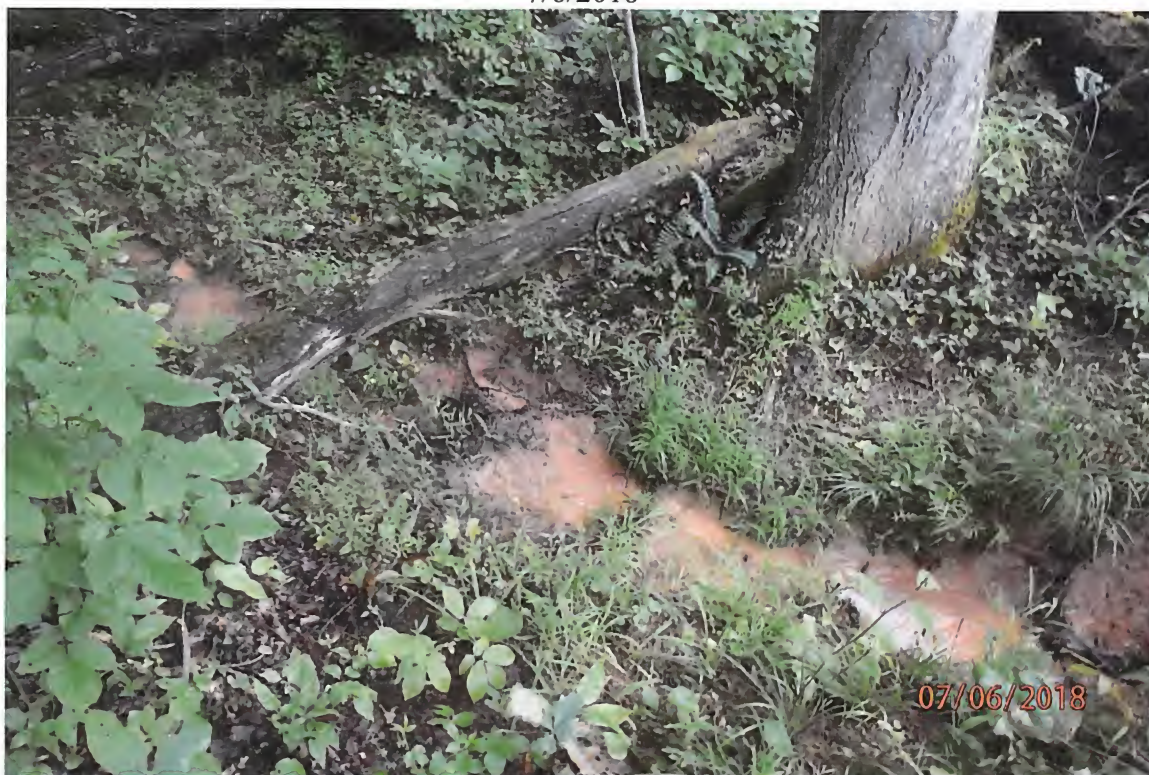
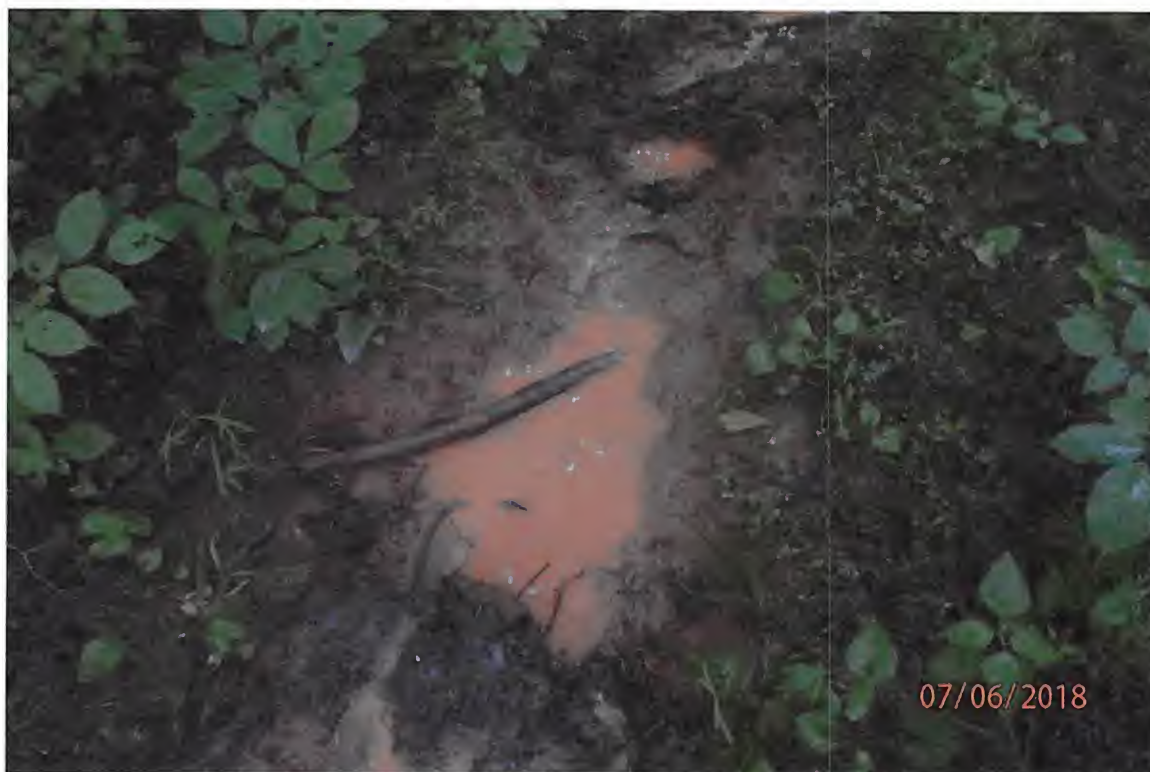
Sediment laden water in UNT Meathouse Fork ($39^{\circ} 11.891'$ X $80^{\circ} 33.209'$) that originates from site.

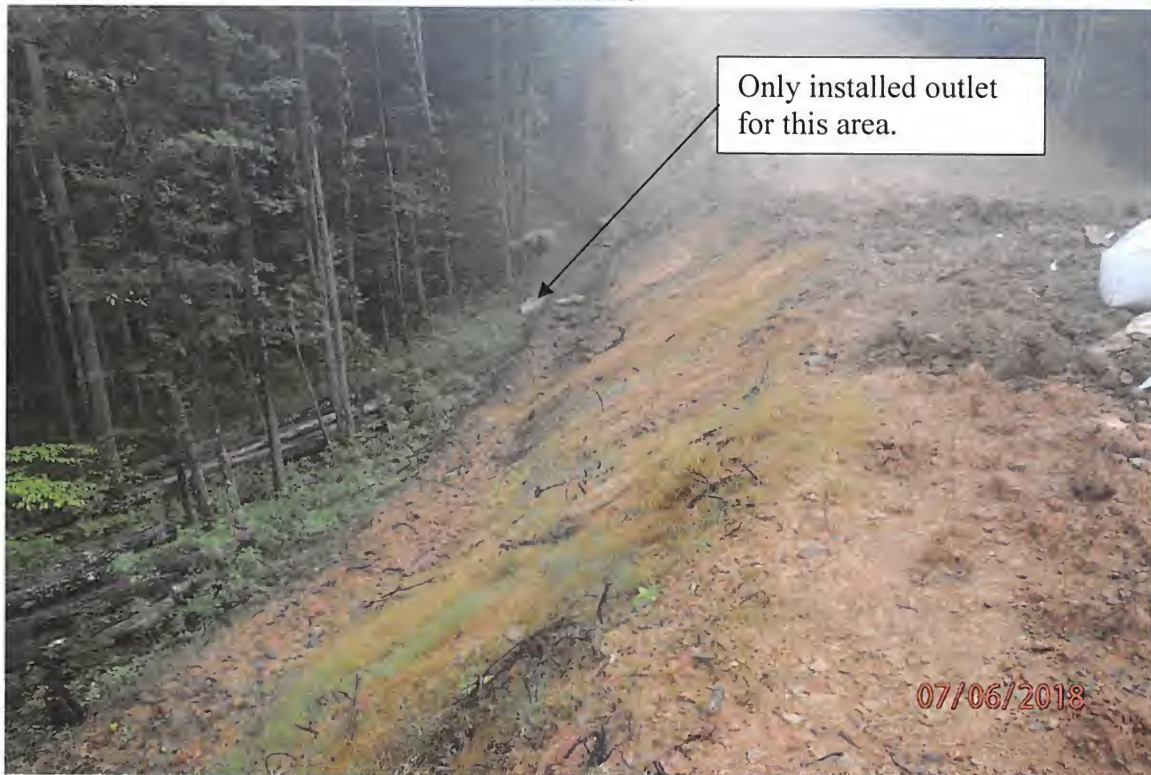
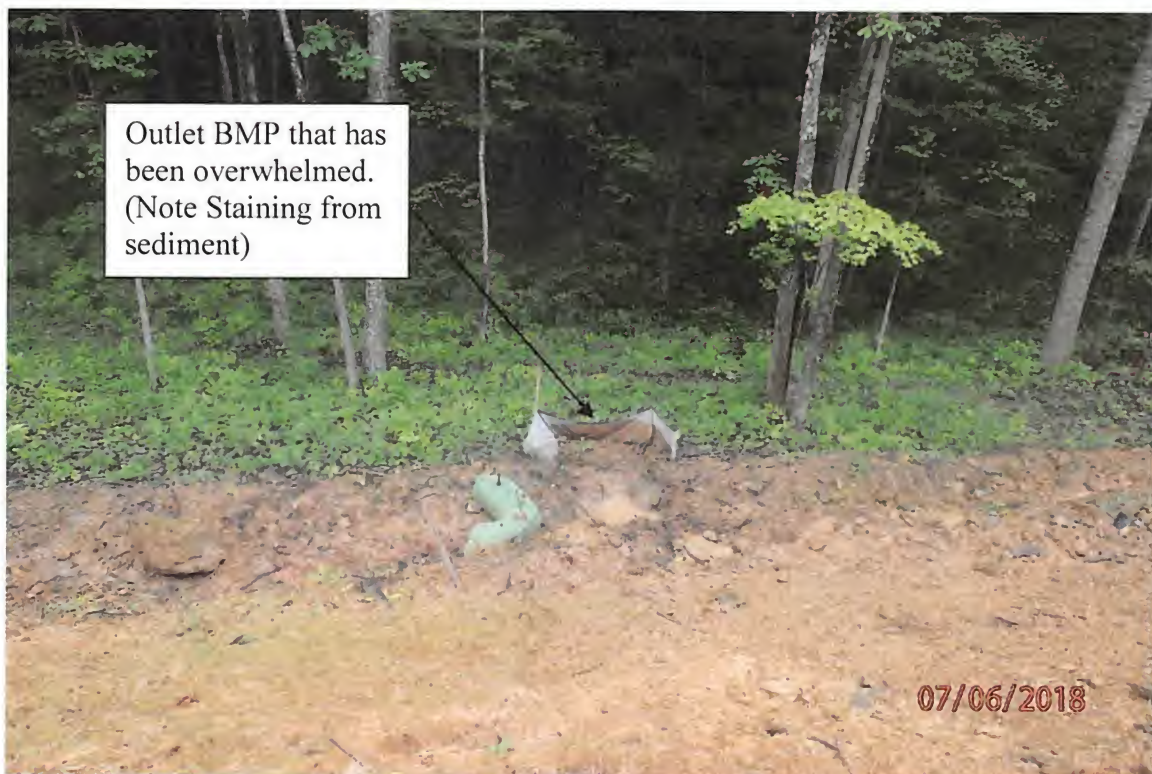
Installed temporary tight of way diversion and outlet that does not have adequate outlets adjacent to 1876+00. Evidence of the terminus BMP being overwhelmed in lower picture.

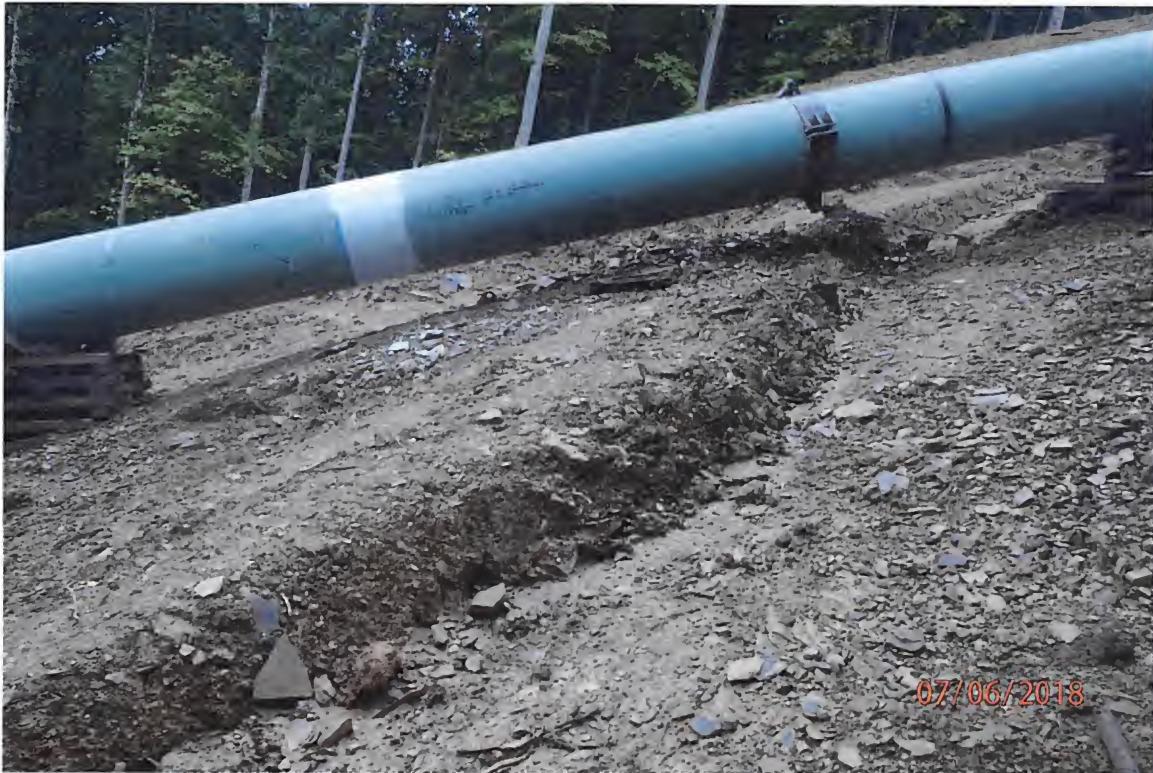
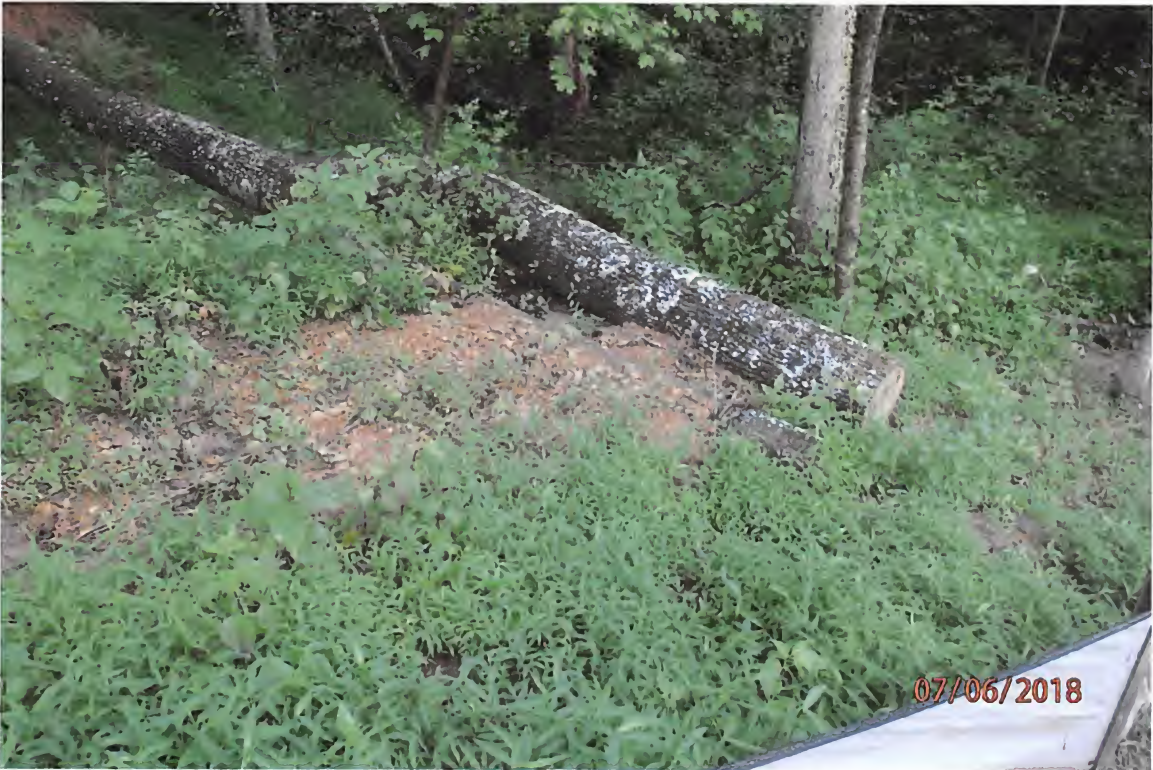
Water bar that has been installed at a steep angle with erosion and the associated offsite sediment deposits.

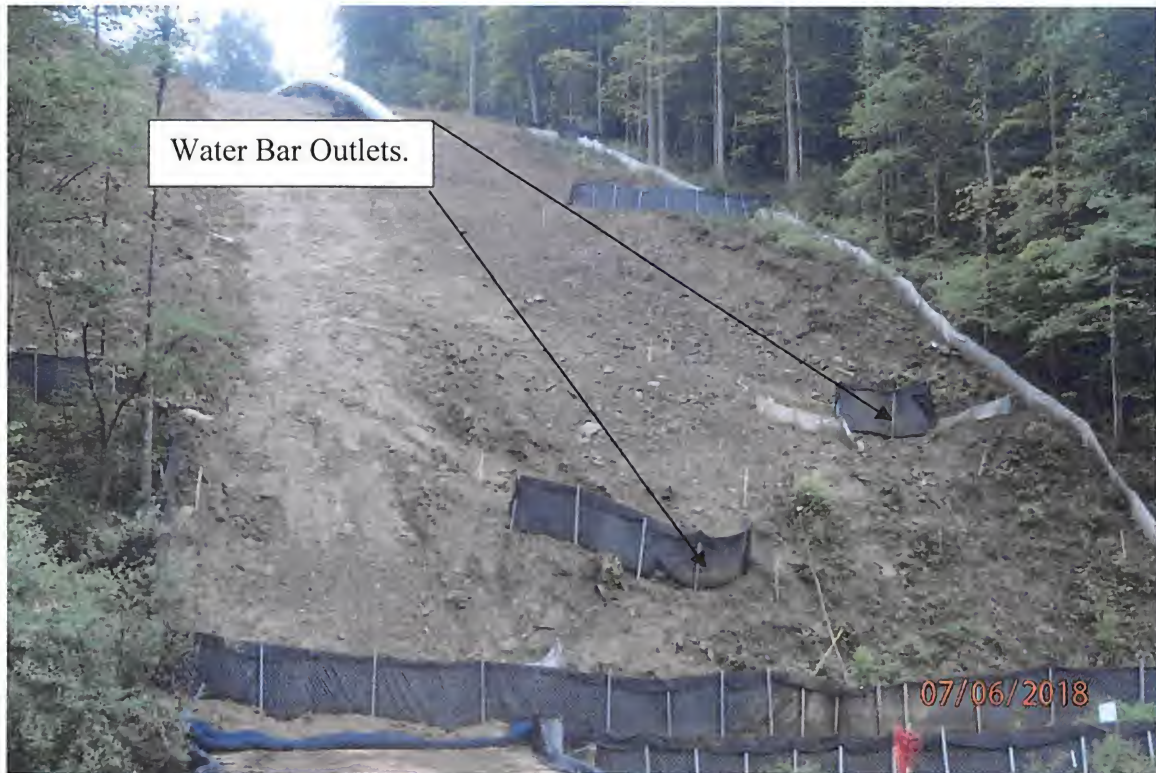
Water bars that are not installed properly and do not shed stormwater off of the LOD in small quantities as designed located adjacent to Laurel Run of Meathouse Fork crossing.

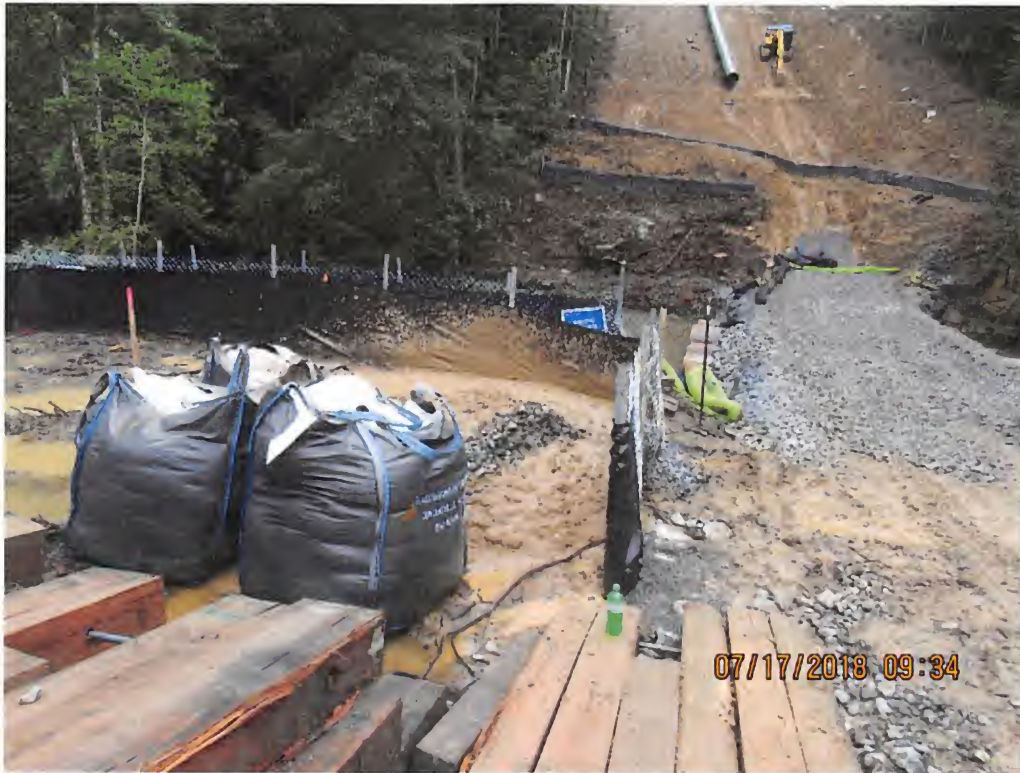
Photo 1: Sump at access road 129 needs maintenance.

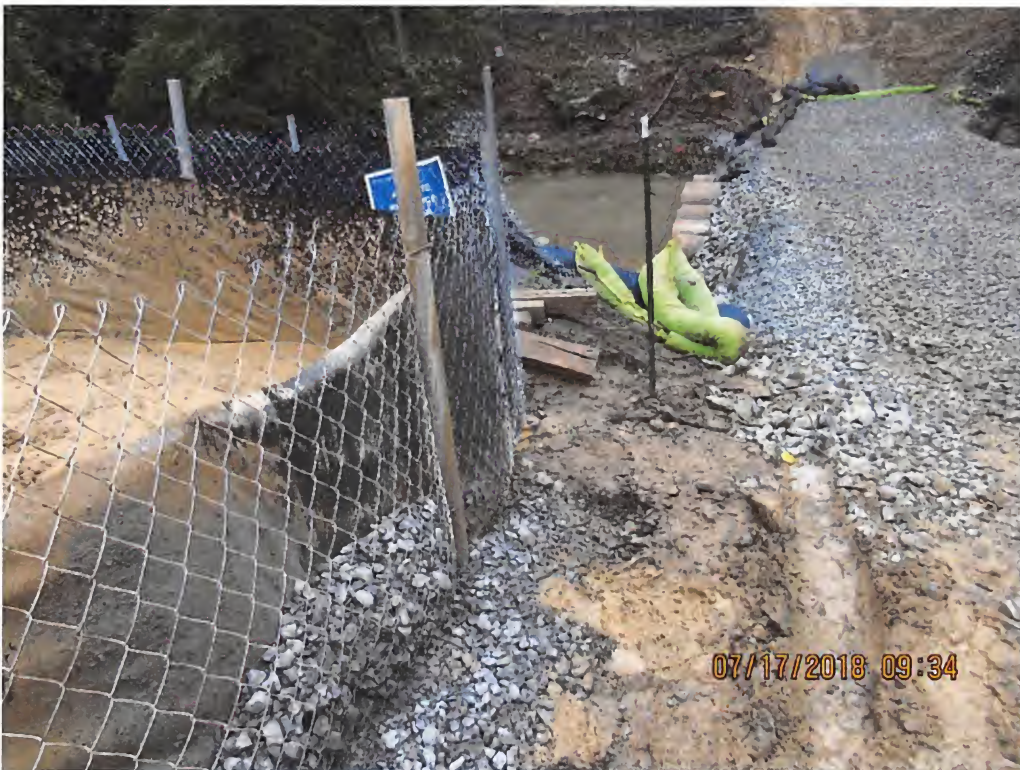
Photo 2: Proximity of outlet of sump and amount of accumulated sediment creates an area of concern.

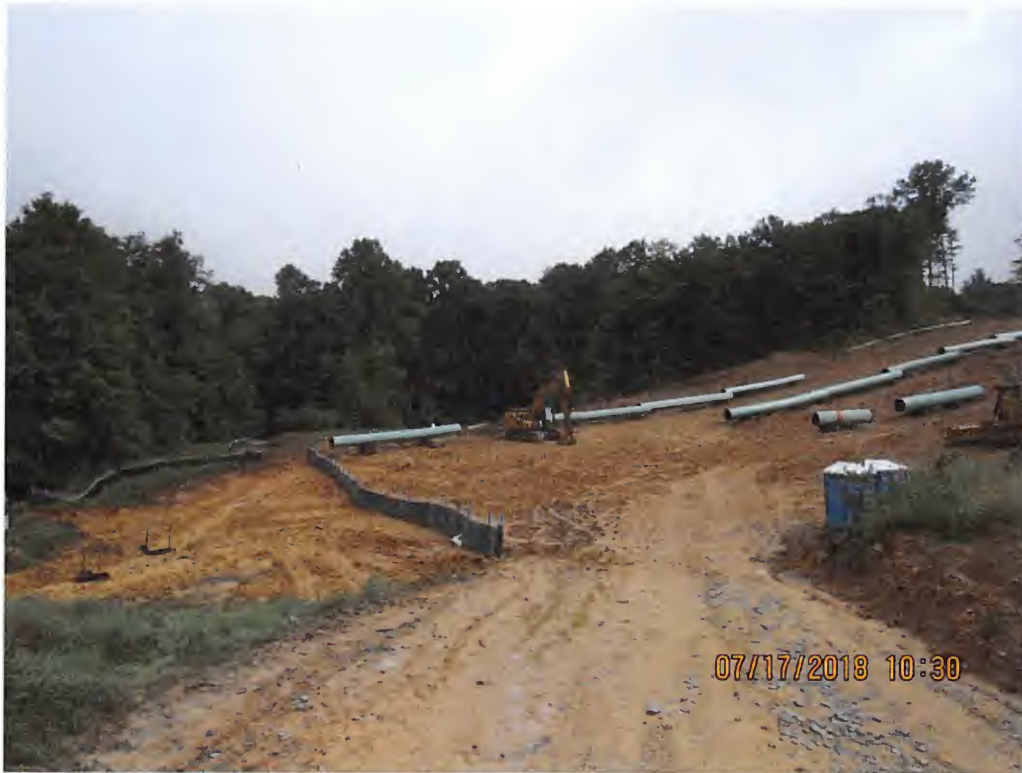
Photo 3: Drainage area where sediment laden water left site.

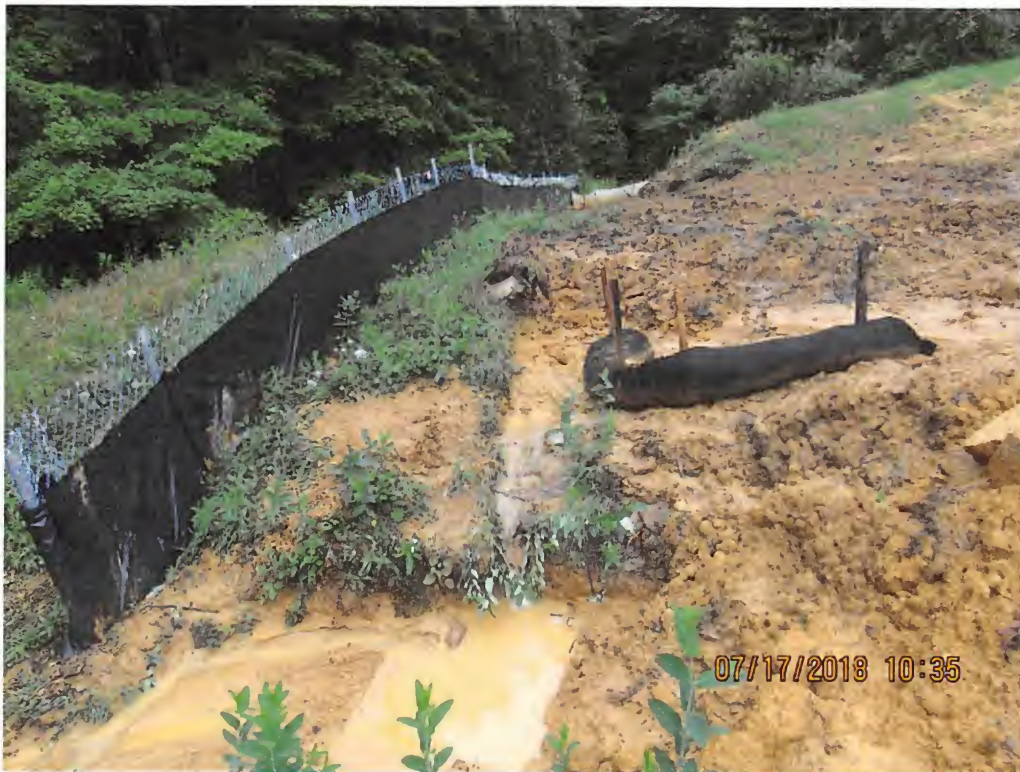
Photo 4: Station 5518+00 where water went around and undercut compost filter sock allowing sediment laden water to leave the site.

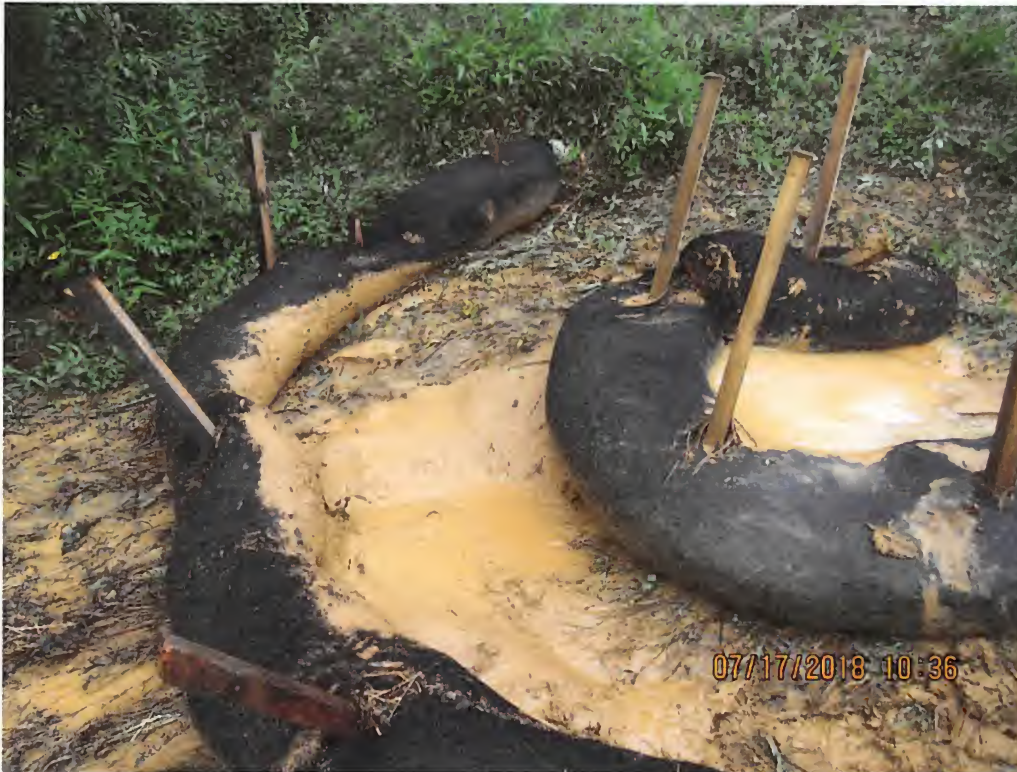
Photo 5: Next set of compost filter sock in sequence which was overtopped allowing sediment laden water to leave site.

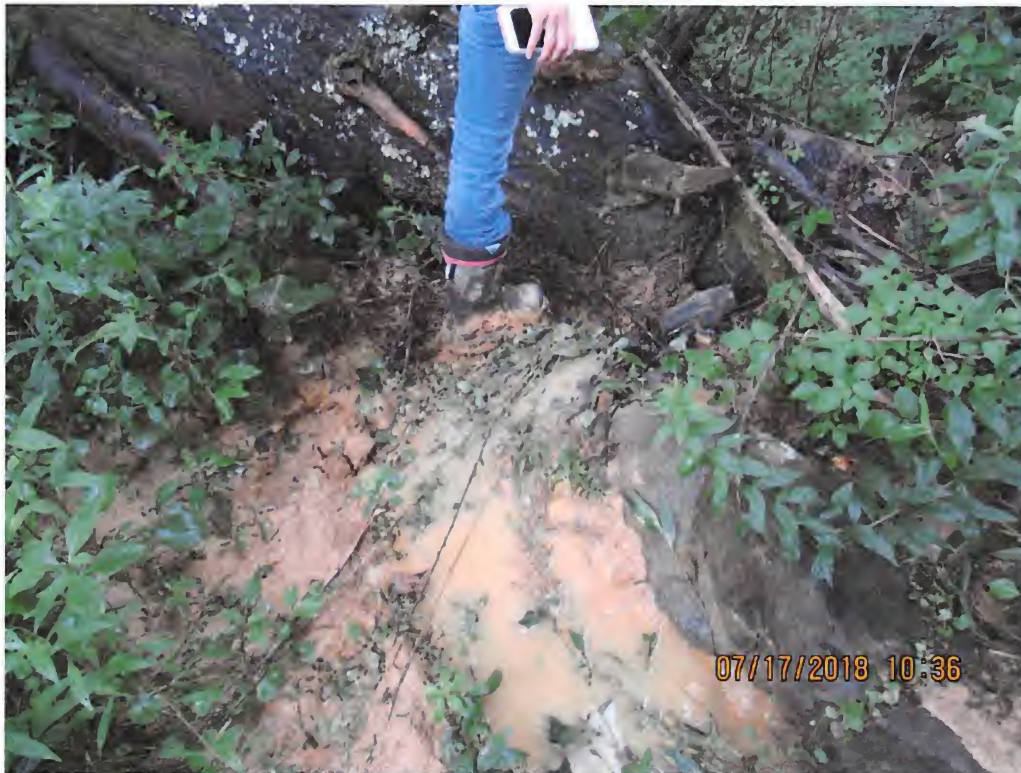
Photo 6: Last compost filter sock in sequence and path sediment laden water created leading to stream.

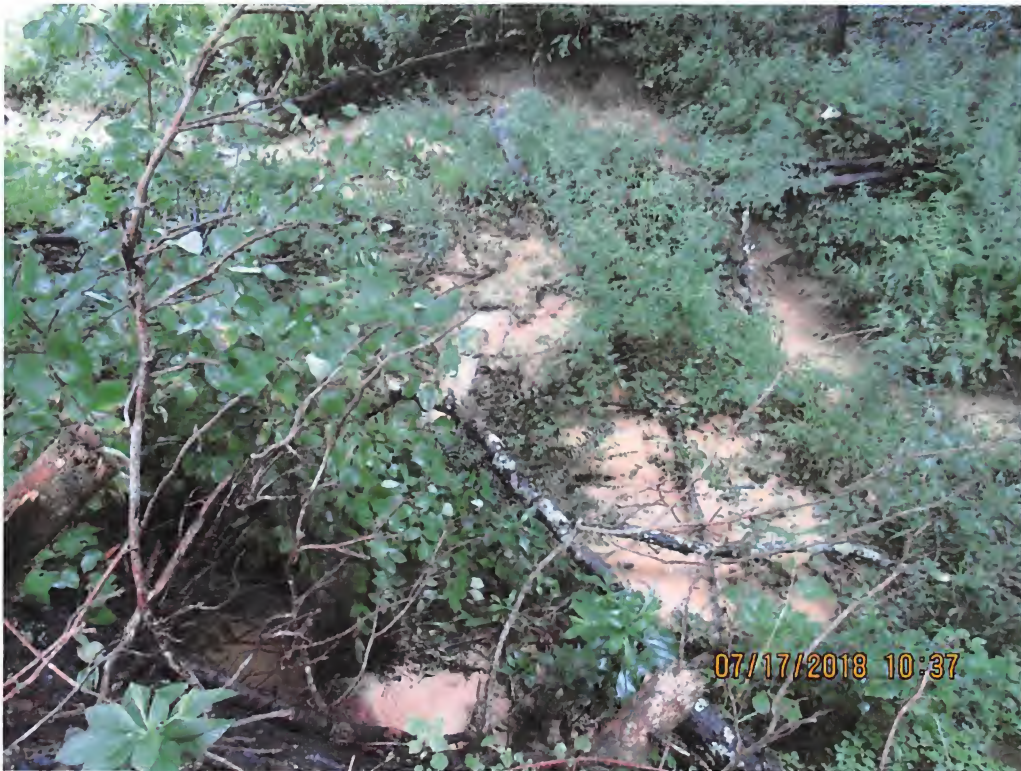
Photo 7: Sediment build up and muddy water temporarily stopped against downed tree.

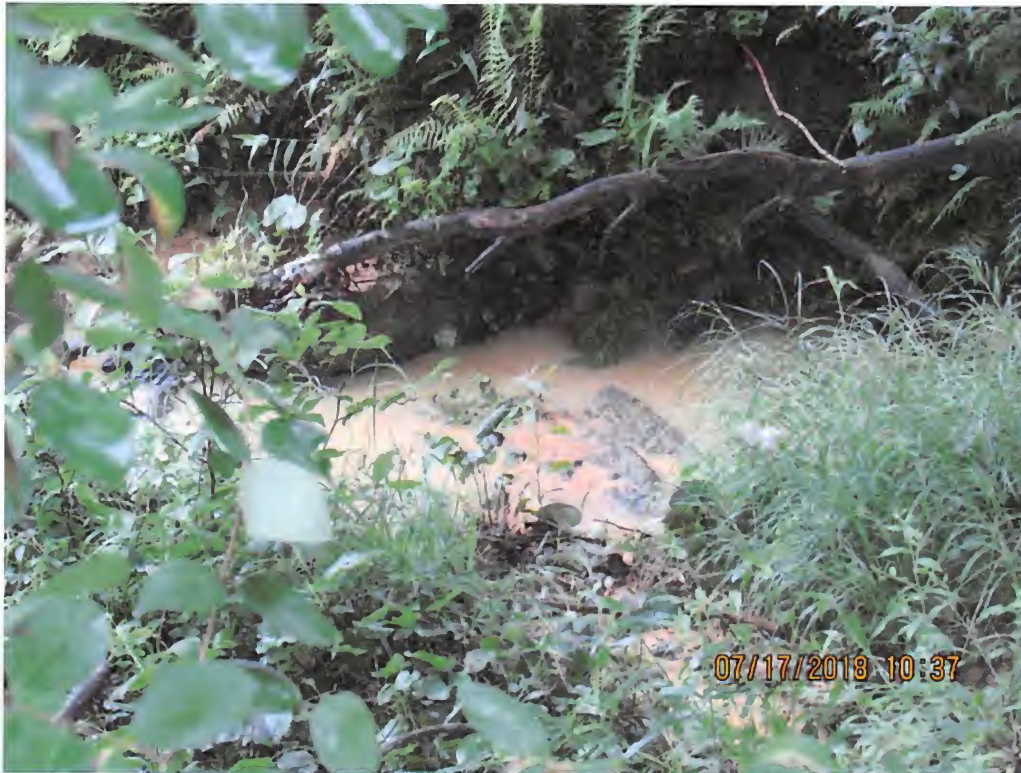
Photo 8: Sediment deposits below temporary tree dam.

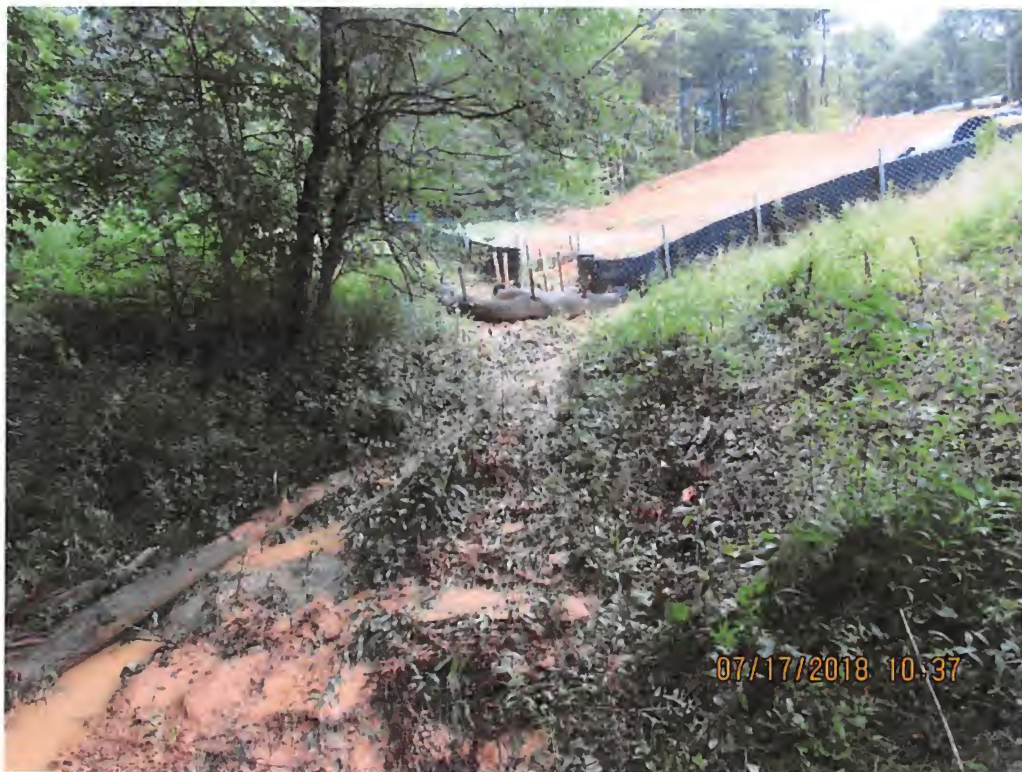
Photo 9: Sediment deposits in UNT of Birch River (S-F34)

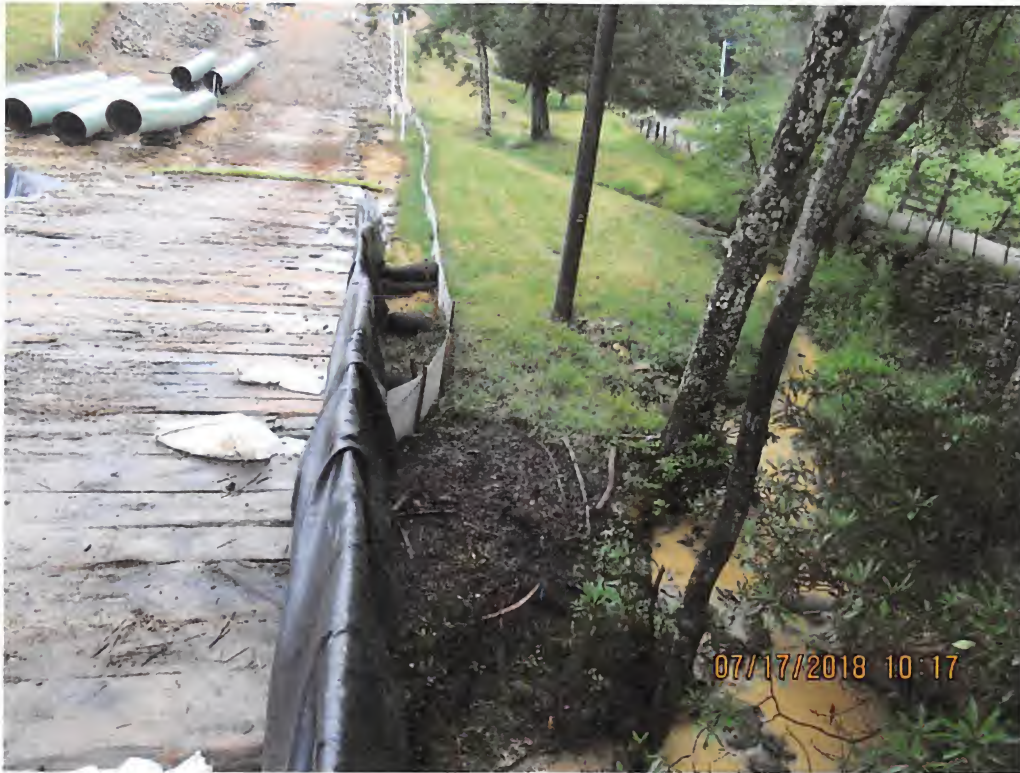
Photo 10: Upslope view of sediment deposits from control failure.

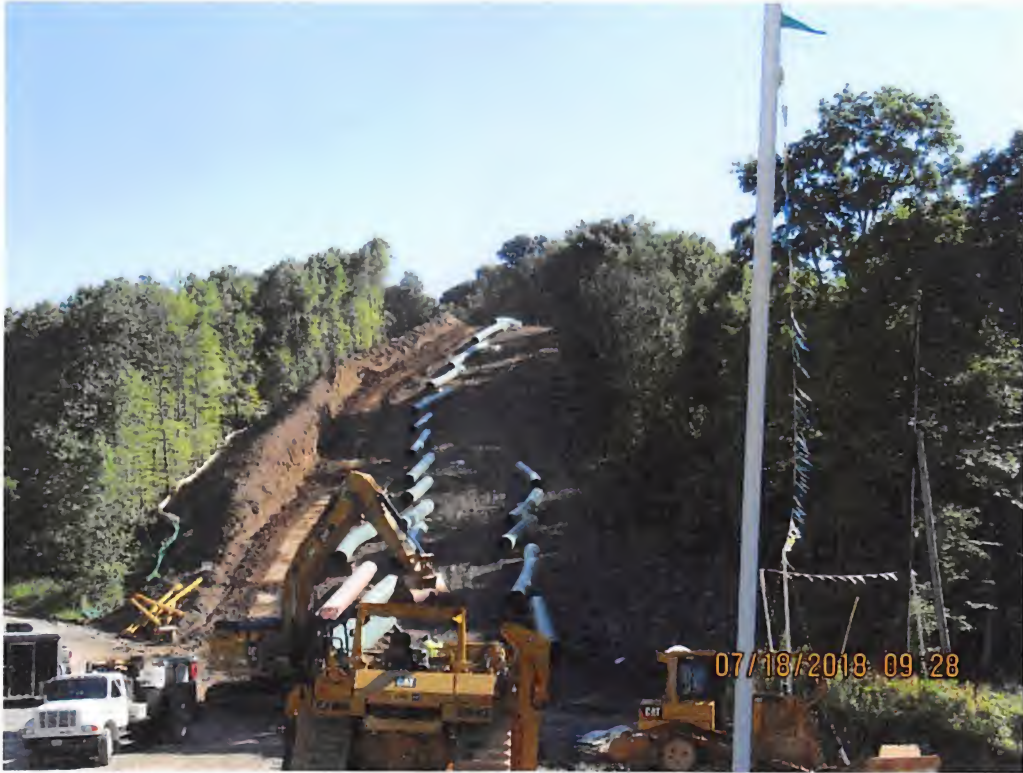
Photo 11: UNT #2 of Birch River (S-F365) at station 5548+00 where breached control upstream allowed sediment laden water in UNT #1 of Birch River (S-F34)

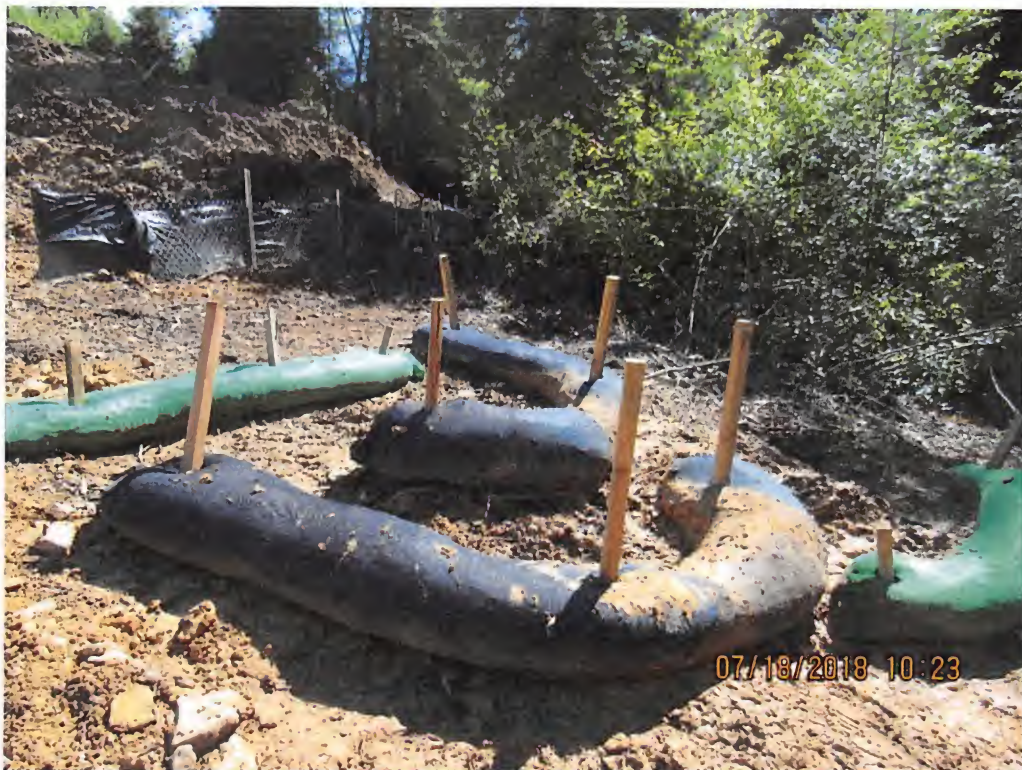
Photo 1: Station 6857+28 at access road 164 without temporary stabilization on large spoil pile. Photo is representative of project.

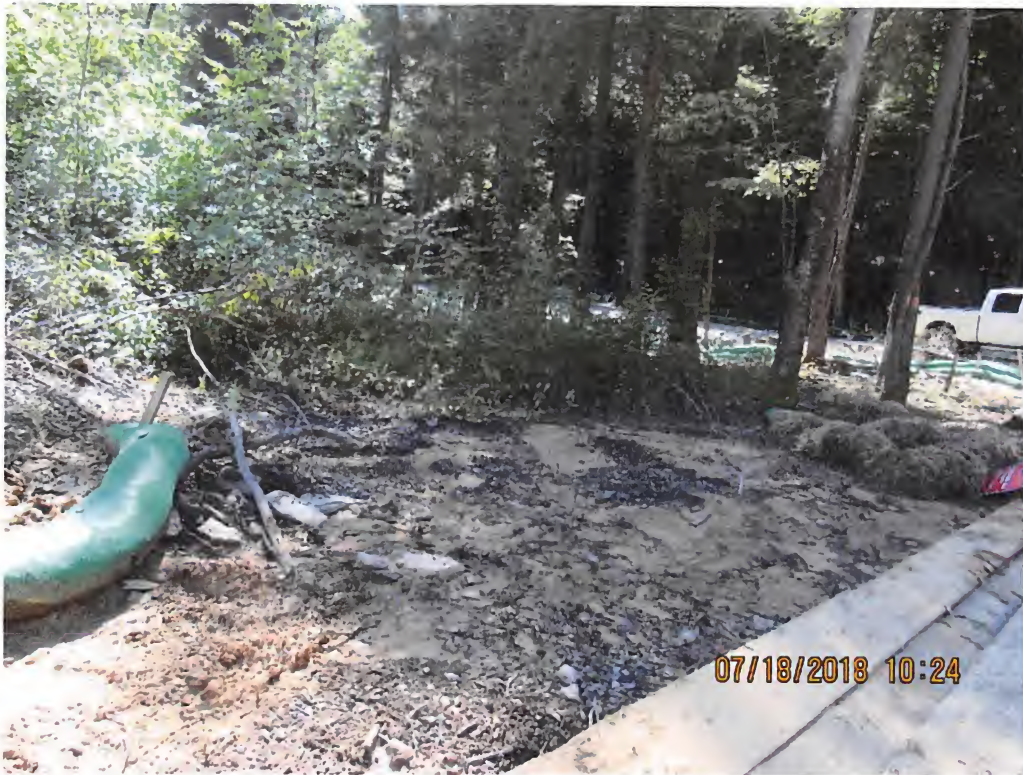
Photo 2: Controls at end of water bar were over topped at station 6898+59.

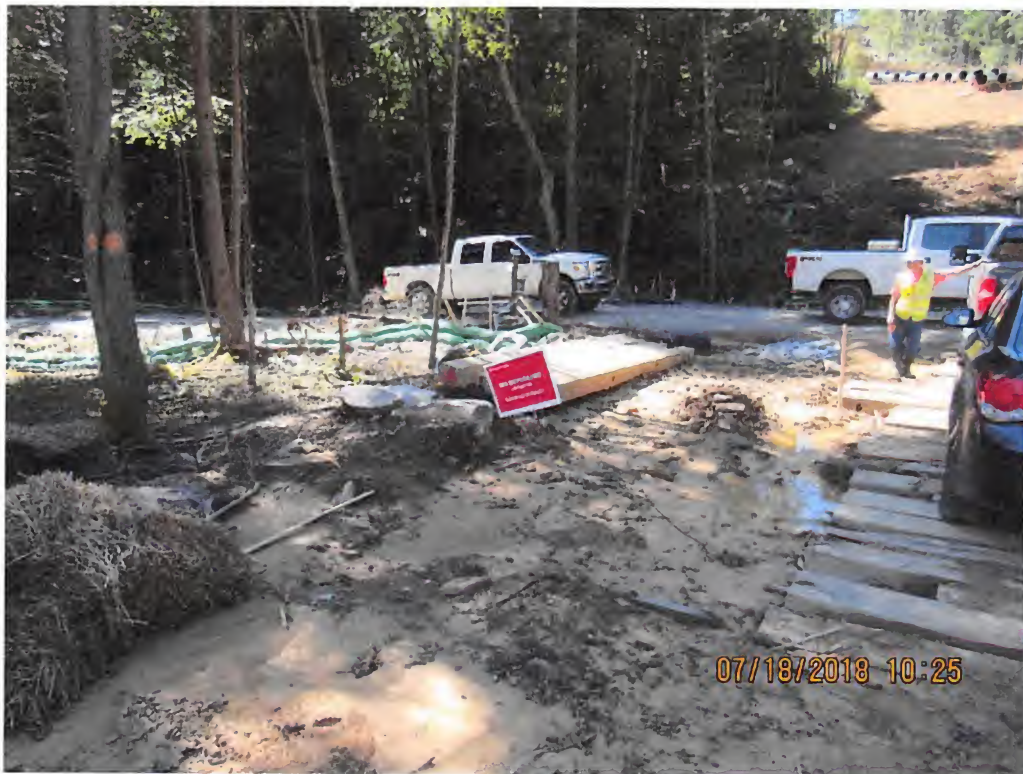
Photo 3: Down gradient of over topped water bar control at station 6898+59.

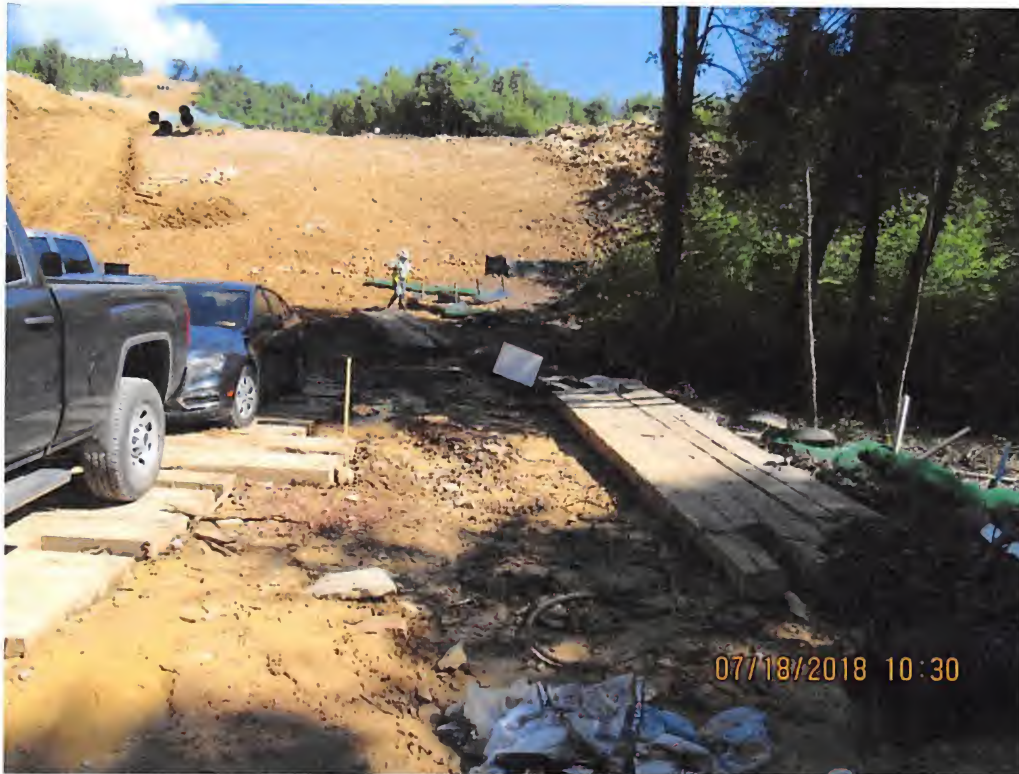
Photo 4: Sediment down gradient of straw bale pile (on right in above photo).

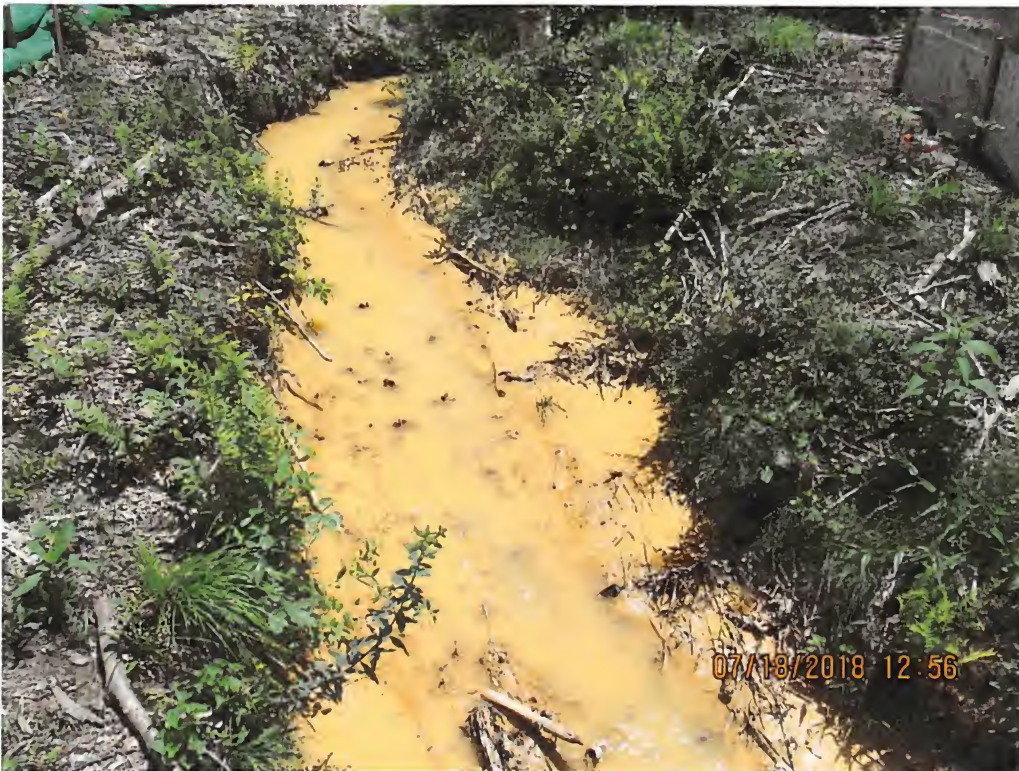
Photo 5: Upslope view of station 6898+59.

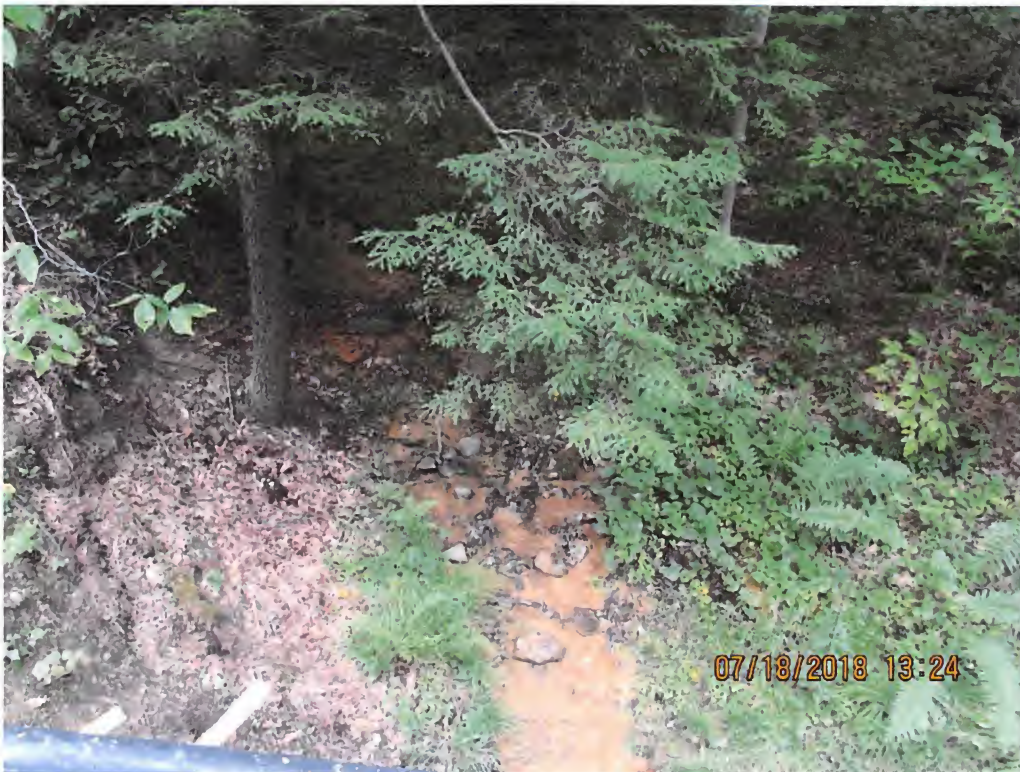
Photo 7: Sediment deposits in UNT of Harmony Creek- upstream of Photo 6. Terminus of control failure in Photos 9 & 10 (vegetation indication under date/time stamp)

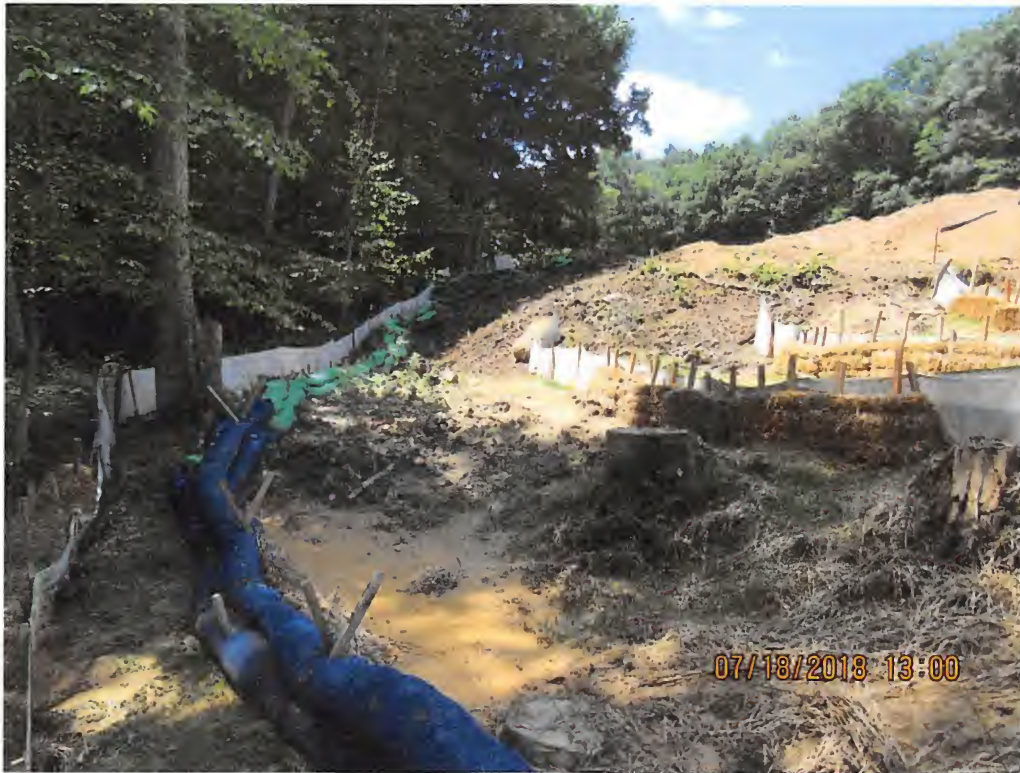
Photo 8: Sediment deposits in UNT of Harmony Creek below 1st water bar failure

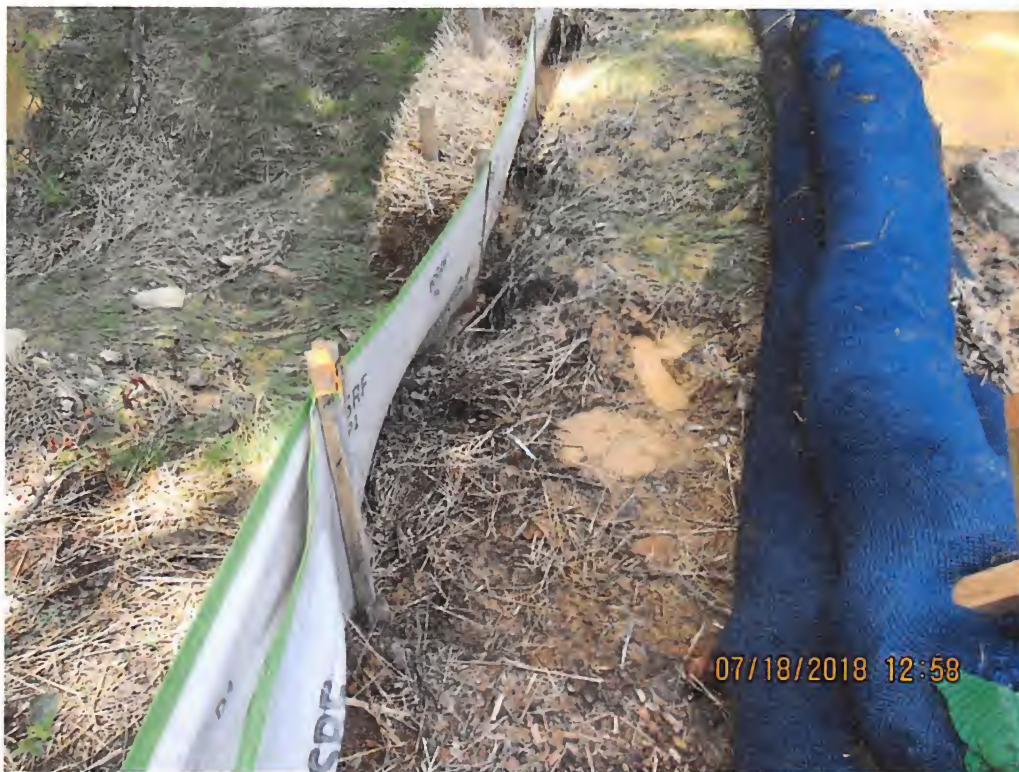
Photo 9: Control sequence near station 6781+87 with multiple control failure.

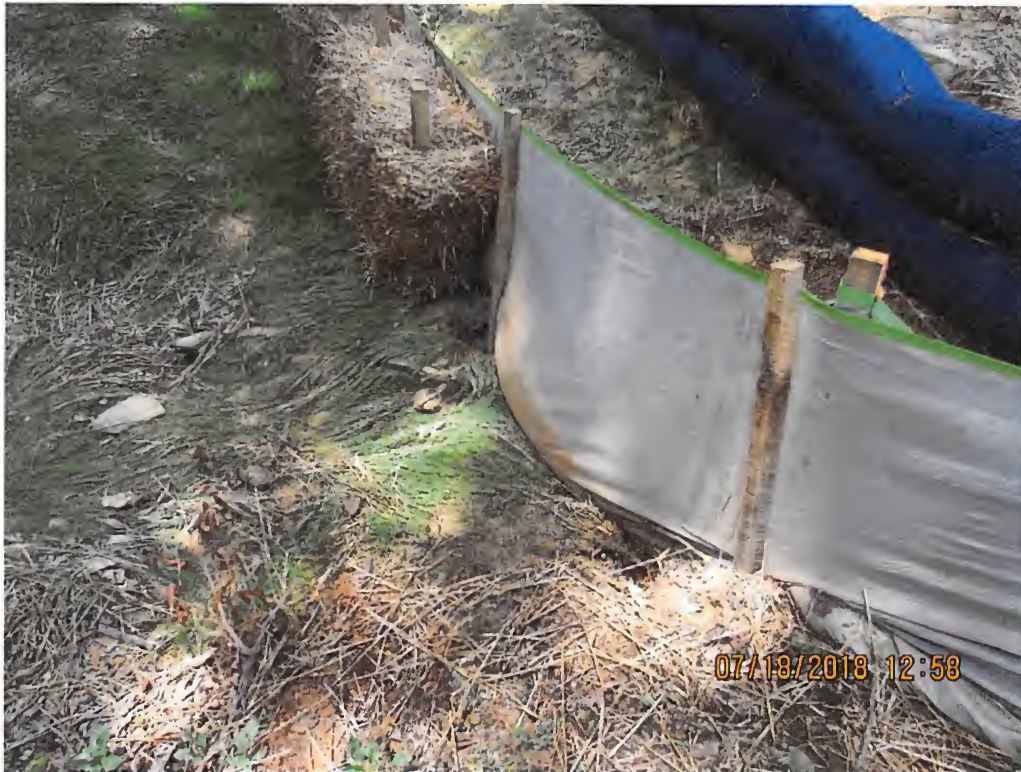
Photo 10: Last control in sequence allowing sediment laden water to leave site.
